HI-FOG® case study

Motala hospital, Sweden

Sweden's Motala Hospital finds fire protection solution it can grow with in major modernization

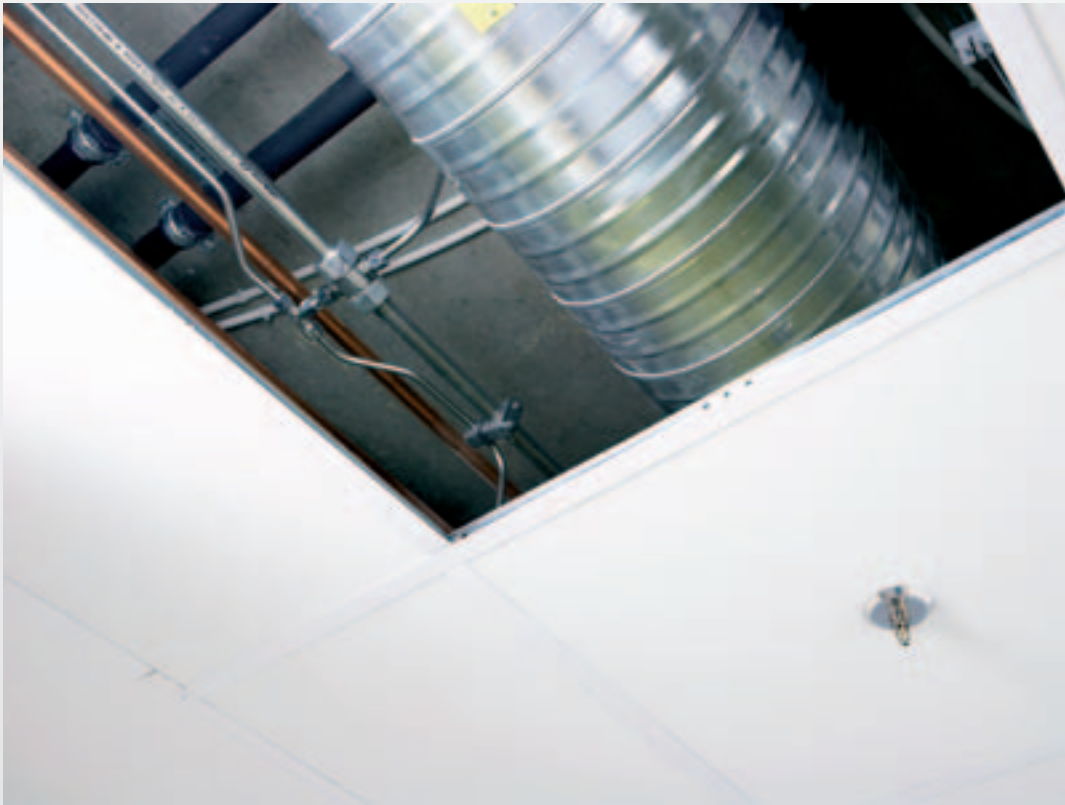
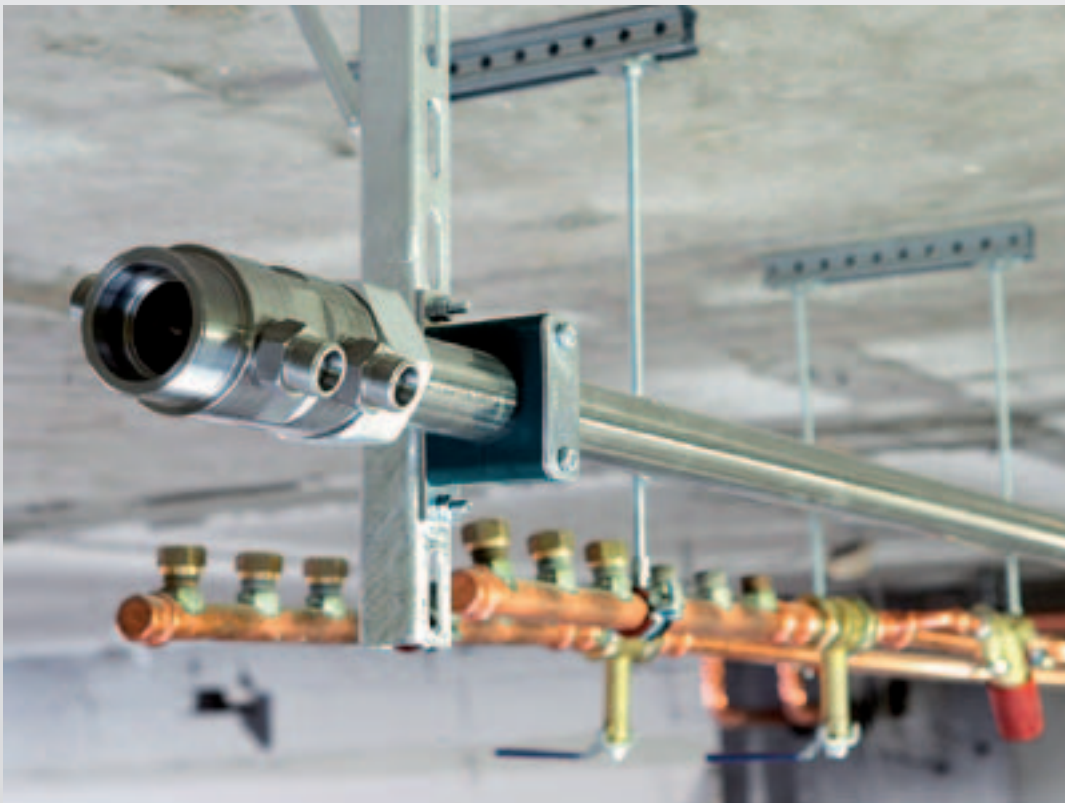
Two views of HI-FOG® system installation in the ongoing Motala Hospital renovation. HI-FOG® tubes are made of high-quality AISI 316L stainless steel, ensuring long life and clean discharge in keeping with the hospital's high standards of hygiene.

HI-FOG® tubes are very small compared to traditional sprinkler system pipes: about $\frac{2}{3}$ of the tubing network of a typical HI-FOG® system for buildings will be composed of 12 mm tubes. An important advantage when space is extremely limited.

While taking up minimum space and conserving water, HI-FOG® is a high-performance, flexible system that covers the entire hospital, not just the high-risk areas. HI-FOG® will protect the entire hospital in accordance with Sweden's SBF 120:6 fire regulation. The electric SPU 4 +1 pump unit and water tank will occupy only 18 cubic metres of space in an old storeroom in the hospital basement, leaving plenty of room for maintenance activities. The system runs up to each floor via 38 mm tubing, with 30 mm tubing on the floor levels, and then 12 mm tubing runs to the HI-FOG® sprinkler heads.

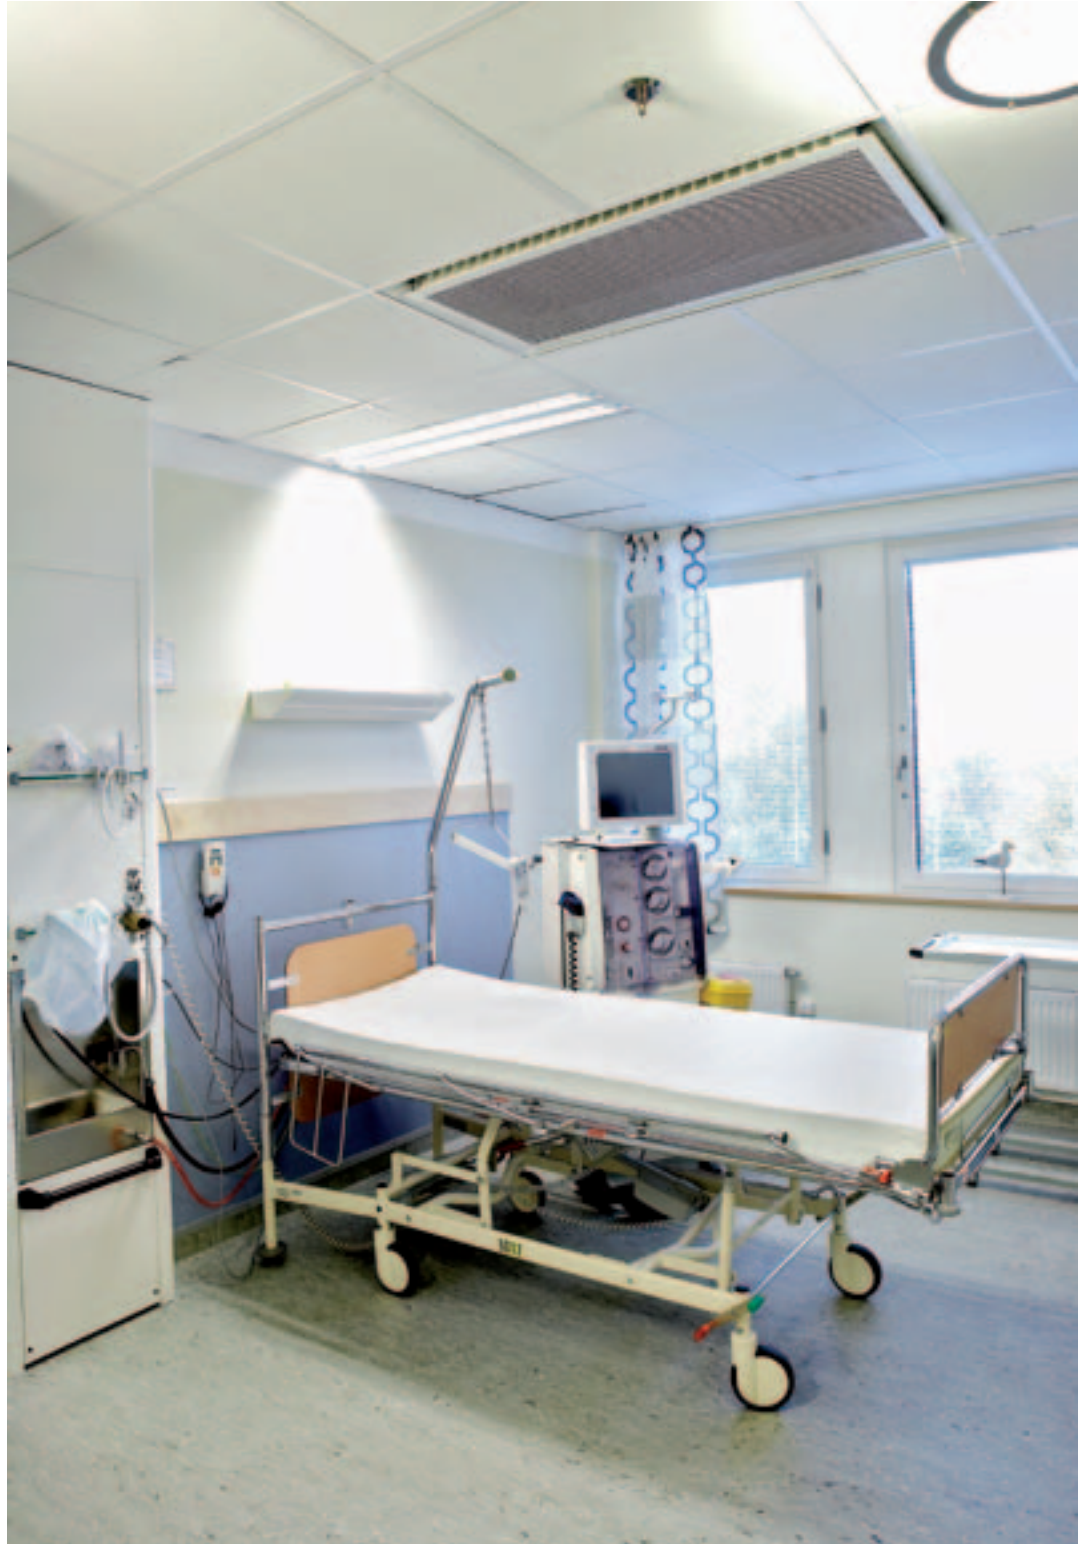
HI-FOG® 2000-series sprinkler heads of the pendent type are installed in the ceilings of all the hospital workspaces. Each sprinkler head provides 25 m² of coverage. Specialized fire protection is also provided by HI-FOG® 2000-series sprinkler heads of the pendent type, mounted inside the lowered corridor ceilings at every third metre. These protect all the cables running there as stipulated by Swedish fire regulation SBF 120:6.
